# A CULTURAL HERITAGE MANAGEMENT PLAN FOR THE RIETVLEI DAM NATURE RESERVE, CITY OF TSHWANE

# THE CITY OF TSHWANE, DEPARTMENT OF HOUSING, CITY PLANNING AND ENVIRONMENTAL MANAGEMENT, DIVISION NATURE CONSERVATION AND RESORTS

REPORT: AE1017

March 2010

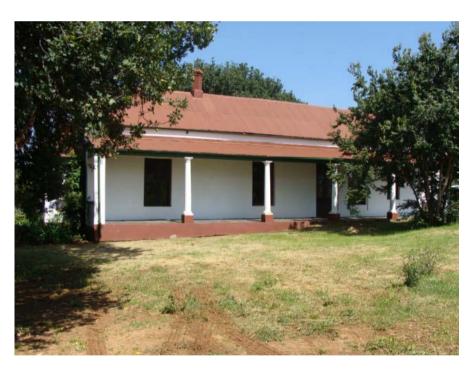
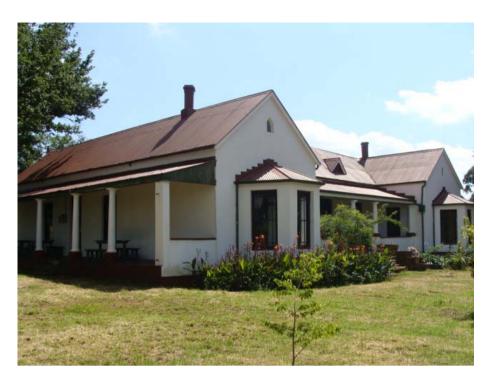
Figure 3 View of the main house.

Figure 4 Another view of the main house.

1. Building such as these needs constant attention and needs to be maintained at all times.

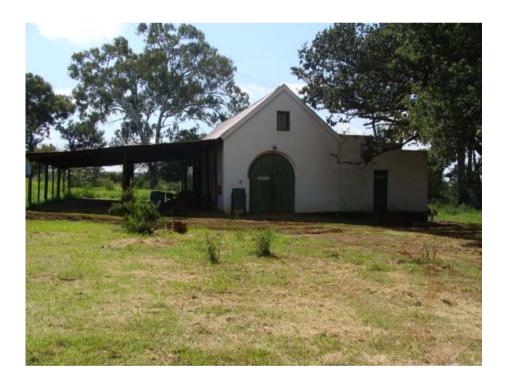
Figure 5 Historical barn on the farm yard.

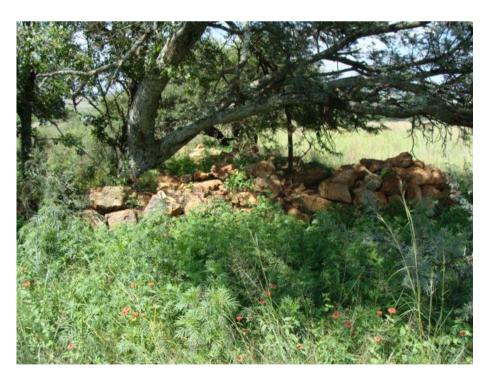
This is a stone wall just beyond the perimeters of the farm yard, forming a rectangle (Figure 6). It is associated with the historical farm and was probably used as fence around a garden or orchid, but it may also have been a cattle kraal.

Figure 6 Part of the stone fence close to the historical farm yard.

- 1. The stone walled enclosure should be kept in tact.
- 2. The vegetation inside and alongside the stone enclosure should be controlled in order to keep it from deteriorating.
- 3. Loose stone should be placed back on top of the walls. Shies should be done under supervision of a person trained in heritage management.
- 4. None of the so-called restoration processes (see Appendix A) may be utilized without consultation with the Gauteng Provincial Heritage Resources Agency.
- 5. The activities of the education centre can be extended to include this area.
- 6. The historical ambiance of the structure should be preserved as far as possible. This means that no new constructions should be allowed within 20 meters from it.
- 7. An adaptation to this management plan should be done after implementation of the above mentioned guidelines.

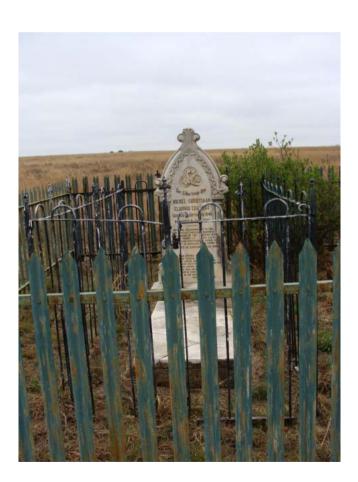
Figure 7 Palisade fence around the grave yard. This grave (MCE Erasmus) also has its own steel fencing around it.

The grave yard is fenced off by a palisade fence (Figure 7). Graves are always regarded as having a high cultural significance.

- 1. Graves are an extremely sensitive issue and therefore the grave yard should be preserved at all cost. The fence should be fixed and kept in a good condition.
- 2. The vegetation should be kept in control.
- 3. It would be of benefit to visitors if a short history of the graves could be available, either on a brochure or a display panel at the grave yard.
- 4. Should any developments that may have an impact on the site be planned, it should be re-evaluated within the context of this management plan.

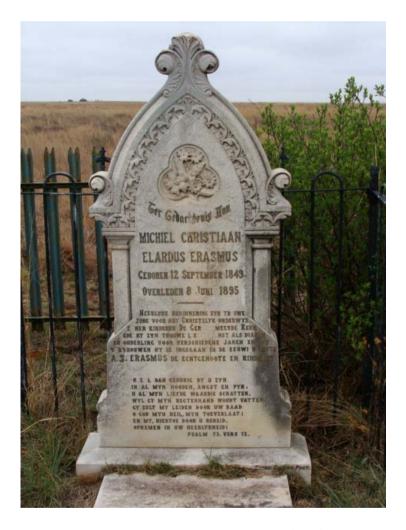
The first grave is that of Michiel Christiaan Elardus Erasmus. He was born on 12 September 1849 and died on 8 June 1895 (Figure 8). The Erasmus family was the first owners of the farm Rietvallei. However it is believed that the person buried here was owner of the farm Witkoppies. He is the one who was married to JGC Bronkhorst (see tables earlier). The grave has a cement border and headstone.

Figure 8 Headstone on the grave of MCE Erasmus.

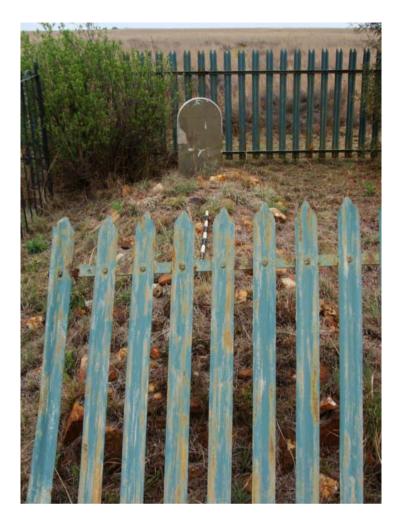
The second grave is the one of Petrus Jacobus van Staden who died on 30 June 1918 at the age of 30 years, 2 months and 2 days (Figure 9). Although it is not indicated on his grave stone, he therefore must have been born on 28 April 1888.

The grave has a packed stone dressing. The head stone is made of cement.

Figure 9 Grave of Jacobus van Staden.

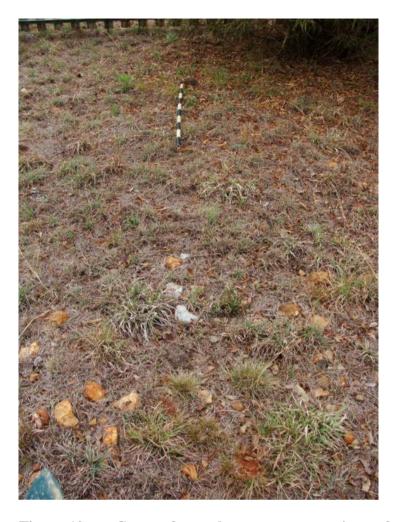
The third grave is an unknown one. It has a stone dressing and no headstone (Figure 10).

Figure 10 Grave of an unknown person at site no 3.

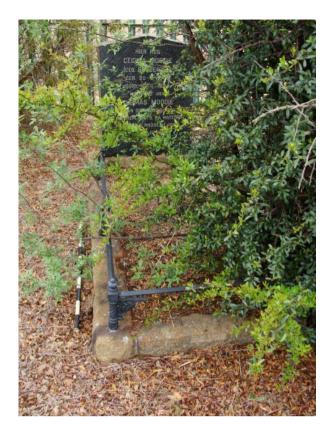
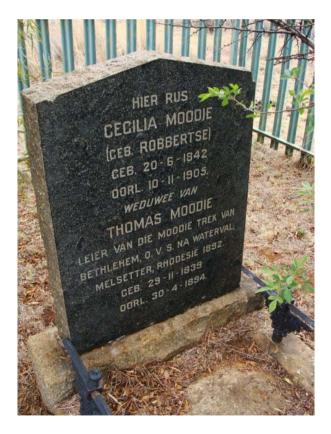
The fourth grave is that of Cecilia Moodie (neé Robbertse). She was born on 20 June 1842 and died on 10 November 1905 (Figure 11-12). She was the wife of Thomas Moodie, trek leader of the Moodie trek who moved from Betlehem to Rhodesia in 1892.

The grave has a cement border with a decorative metalwork fence. The headstone is made of granite.

Figure 11 Grave of Cecilia Moodie.

Figure 12 Inscription on the headstone of Cecilia Moodies' grave.

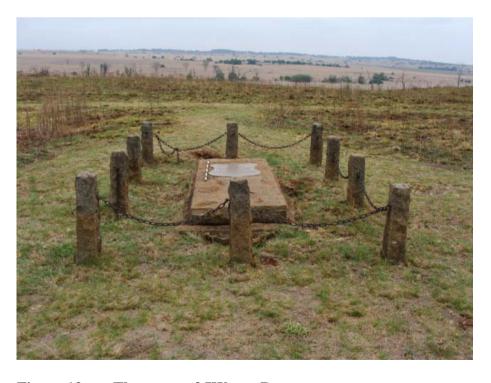
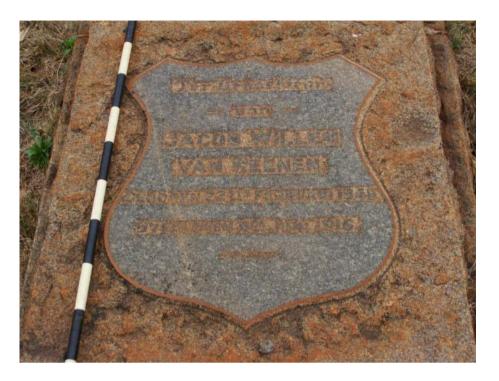
Graves are always regarded as having a high cultural significance. This one is older than 60 years and is therefore regarded as an archaeological grave.

Figure 13 The grave of JW van Reenen.

Figure 14 Shield with inscription on the grave of JW van Reenen.

- 1. Graves are an extremely sensitive issue and therefore the grave should be preserved at all cost. The fence should be fixed and kept in a good condition.
- 2. Vegetation should be controlled so that it does not damage the grave.
- 3. It would be of benefit to visitors if a short history of the graves could be available, either on a brochure or a display panel at the grave yard.
- 4. Should any developments that may have an impact on the site be planned, it should be re-evaluated within the context of this management plan.

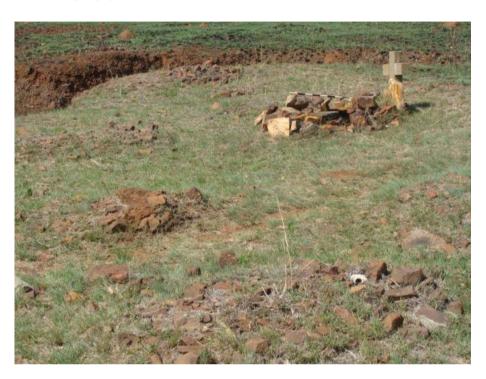
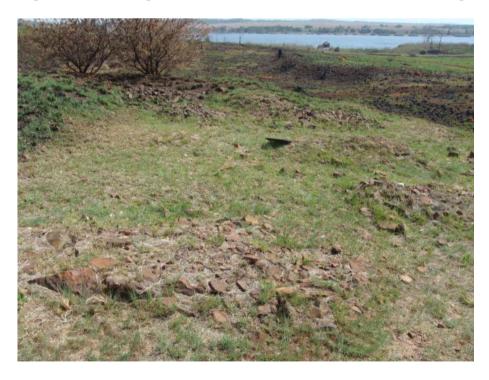
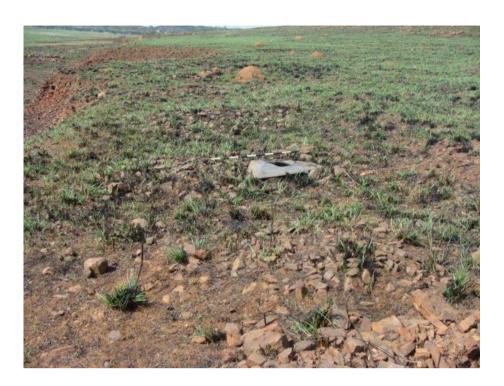
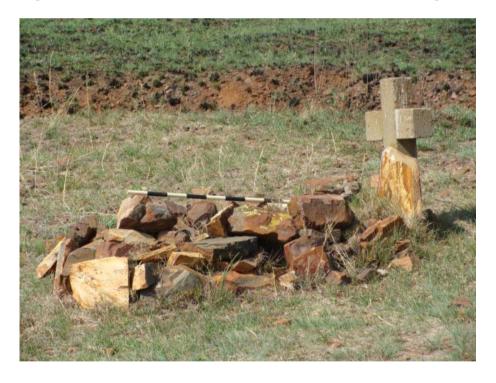
As the dates of death are unknown the graves needs to be regarded as archaeological graves. The one date known, 1897, is certainly older than 60 years and is therefore definitely an archaeological grave. Graves always have a high cultural significance.

Figure 15 The graves on the northern side of the erosion donga at site no 5.

Figure 16 Another part of the grave yard.

Figure 17 Graves on the southern side of the erosion donga.

Figure 18 Grave with concrete cross as headstone.

1. Graves are an extremely sensitive issue and therefore the graves should be preserved at all cost.

- 2. Urgent stabilization of this site is needed as it seems as if the graves are being washed away due to the slope where it is positioned. This should be done by strengthening and supporting the ground wall where the grave yard is situated.
- 3. A suitable fence should be erected and kept in a good condition.
- 4. The vegetation should be controlled in order to prevent further deterioration of the site.
- 5. It would be of benefit to visitors if a short history of the graves could be available, either on a brochure or a display panel at the grave yard.
- 6. Should any developments that may have an impact on the site be planned, it should be re-evaluated within the context of this management plan.

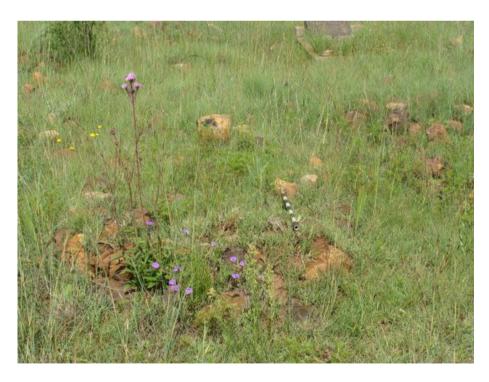
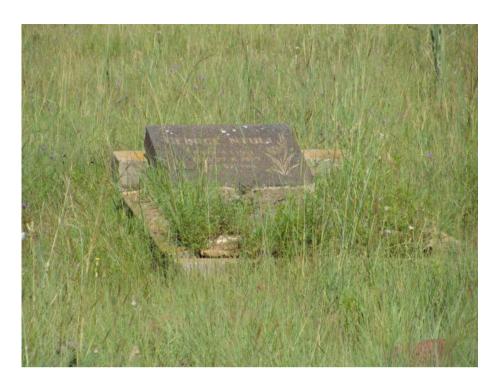
As the dates of death of all the others are unknown these also needs to be regarded as archaeological graves. Graves always have a high cultural significance.

Figure 19 Some of the graves at site no 6.

Figure 20 The grave of Daniel Mamakoe.

- 1. Graves are an extremely sensitive issue and therefore the graves should be preserved at all cost.
- 2. A suitable fence should be erected and kept in a good condition.
- 3. The vegetation should be kept neat.
- 4. It would be of benefit to visitors if a short history of the graves could be available, either on a brochure or a display panel at the grave yard.
- 5. Should any developments that may have an impact on the site be planned, it should be re-evaluated within the context of this management plan.

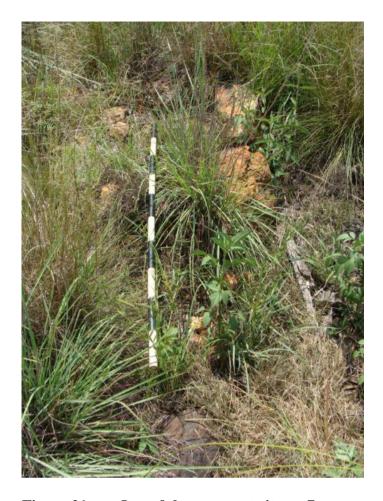
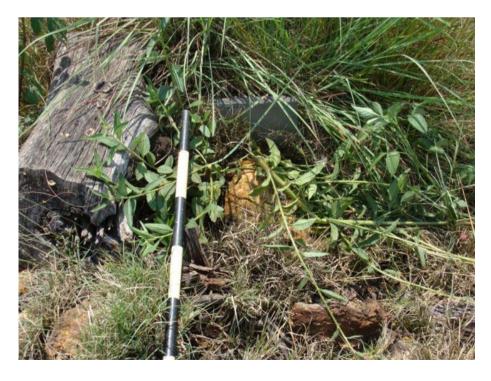
As the dates of death are unknown the graves also needs to be regarded as archaeological graves. Graves always have a high cultural significance.

Figure 21 One of the graves at site no 7.

Figure 22 Another grave at site no 7 showing a slate headstone.

- 1. Graves are an extremely sensitive issue and therefore the graves should be preserved at all cost.
- 2. A suitable fence should be erected and kept in a good condition.
- 3. The vegetation should be kept neat.
- 4. It would be of benefit to visitors if a short history of the graves could be available, either on a brochure or a display panel at the grave yard.
- 5. Should any developments that may have an impact on the site be planned, it should be re-evaluated within the context of this management plan.

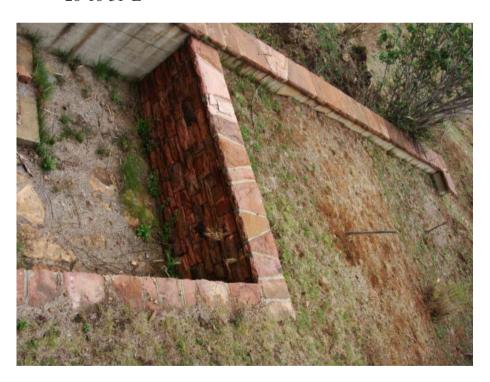
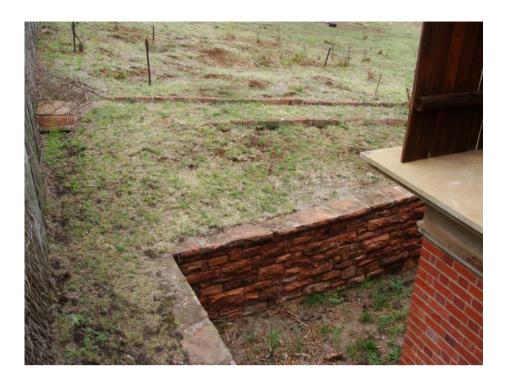
Since the water system on the reserve is very important, the man-made features connected thereto is of a similar importance. The site therefore has a medium cultural significance.

Figure 23 Original brick and stonework at site no 7.

Figure 24 Another view of site no 7.

- 1. The original building material should be kept in tact as far as possible. However, since the feature is still active it may be difficult. It is therefore important to make any necessary changes sympathetic to the original.
- 2. The vegetation should be controlled in order to preserve the site.
- 3. An adaptation to this management plan should be done after implementation of the above mentioned guidelines and it should also be relooked if any development is planned which may have an impact on the furrow system.

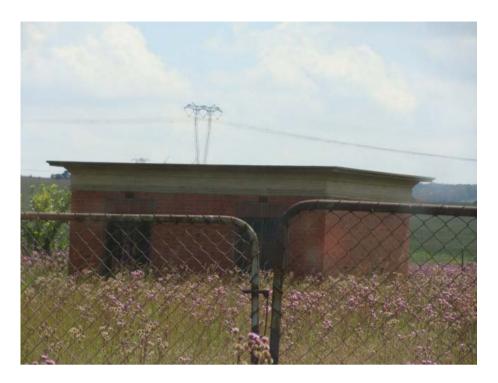
Figure 25 Feature no 8.

This is a small building that is probably also used as a pump house. It is still in working condition. The brickwork may date back as far as the 1940's-1960's (Figure 25). The cultural significance of the feature is medium.

- 1. The original building material should be kept in tact as far as possible. However, since the feature is still active it may be difficult. It is therefore important to make any necessary changes sympathetic to the original.
- 2. The vegetation should be controlled in order to preserve the building.
- 3. An adaptation to this management plan should be done after implementation of the above mentioned guidelines and it should also be relooked if any development is planned which may have an impact on the furrow system.

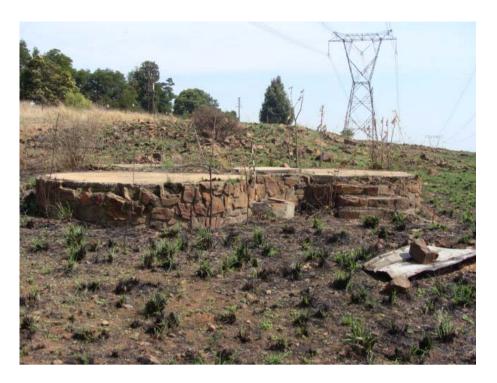
This is the remains of a building in a clover shape which had three rooms (Figure 26). Only the foundations remained. It may have been a lookout point in the past, but does not seem to be very old. The cultural significance therefore is low.

Figure 26 Foundations of the building numbered feature 9.

- 1. The foundations are in a good condition and may therefore be re-utilized.
- 2. No specific heritage related matter needs to be addressed.

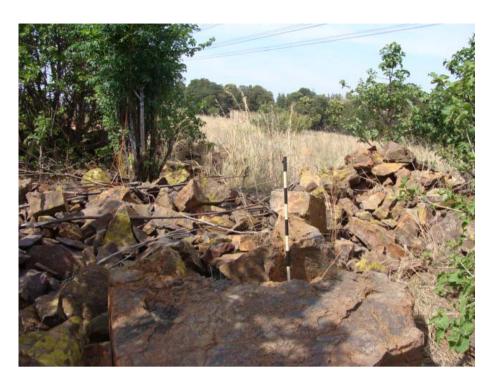
The site consists of roughly built stone walls with a stone platform in the middle (Figure 27). It is similar to fortifications built during the Anglo-Boer War (1899-1902) and it is therefore suggested that it may have been the foundation platform for a block house with associated military features.

The site is of a high cultural significance.

Figure 27 Stone remains that may be of a military origin and was probably built during the Anglo Boer War (1899-1902).

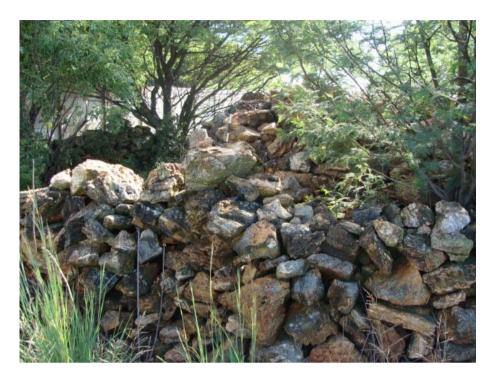
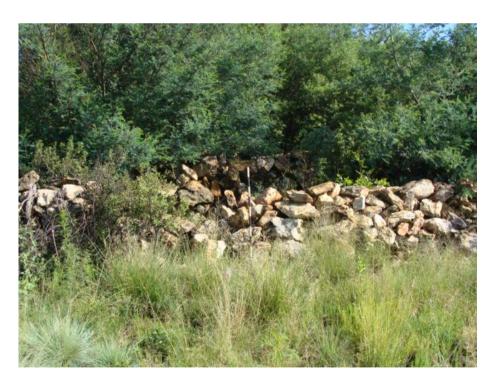
This is the remains of a block house from the Anglo Boer War (1899-1902). e site consists of roughly built stone walls with a stone platform in the middle (Figure 28-29). It is similar to fortifications built during the Anglo-Boer War (1899-1902) and it is therefore suggested that it may have been the foundation platform for a block house with associated military features.

The feature consists of loosely packed stone forming a platform. A circular corrugated iron blockhouse would have been placed on top thereof (Van Vollenhoven 2003b: 15). It is surrounded by a circular shaped stone wall. Pieces of corrugated iron were also found as well

as barbed wire which was used during the War to safeguard the blockhouses. A few stone walled fortification walls are also found to the west of the blockhouse.

Figure 28 View of the platform on which the corrugated iron blockhouse stood and the stone wall surrounding it.

Figure 29 Another view of the platform on which the corrugated iron blockhouse stood and the stone wall surrounding it.

- 1. The site is extremely important and should be preserved at all cost.
- 2. The vegetation should be kept from further damaging it.
- 3. Information about block houses during the Anglo Boer War should be included in a brochure and the site may even be indicated on a map. The site can also be included in horse and walking trails at the reserve.
- 4. Should any developments be planned here it should be re-evaluated, but within the context of this management plan.
